Establishment of Mean High Water Lines in Florida Lakes

*By
John H. Davis, Jr.*

FLORIDA WATER RESOURCES RESEARCH CENTER

RESEARCH PROJECT TECHNICAL COMPLETION REPORT

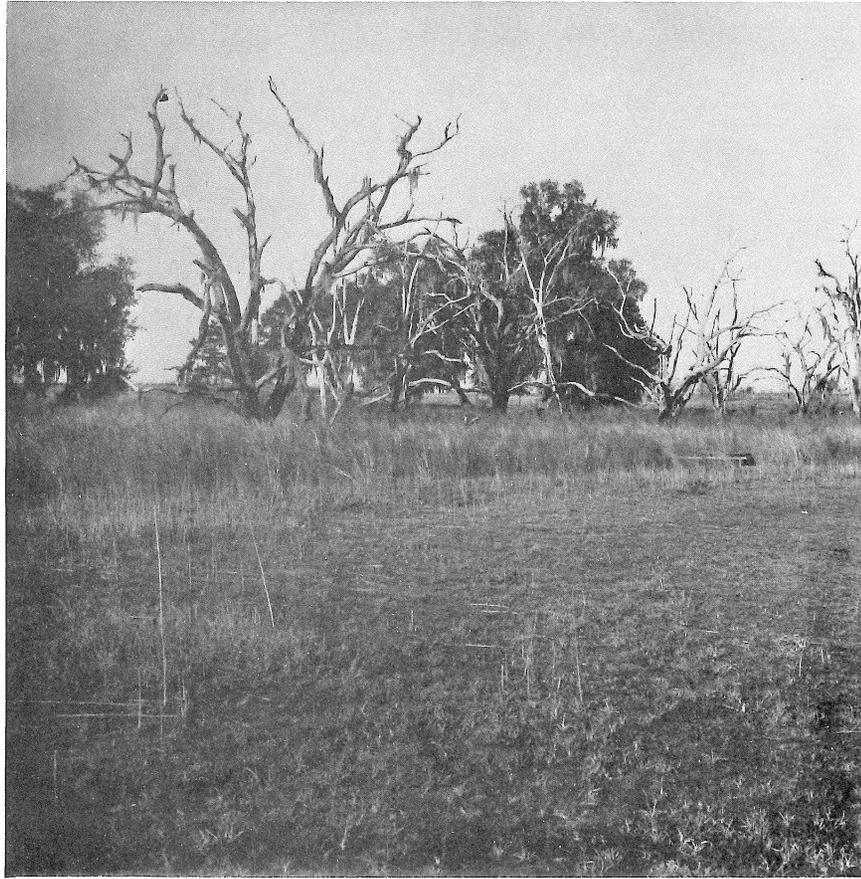
Dead and living live oaks on upland around a Florida lake that has in the recent past had high water levels. This high water killed the live oaks nearest the lake. The nearly bare area in the foreground is the usually sparse growth of herbs of the middle zone of the littoral. The upper zone is indicated by the taller, denser herbs Andropogons and dog fennel.

The upland plants that seldom tolerate water around their bases for long periods of time are a great variety of trees and bushes, many grasses, and a variety of other herbs. Those that grow under the driest conditions are known as xerophytes, and their presence indicates that water has never covered the soil in which they grow for more than a few weeks or a few months. A few of the large trees, especially the live oak and the longleaf pine, are xerophytes, and are useful indicators (see Figure 1).

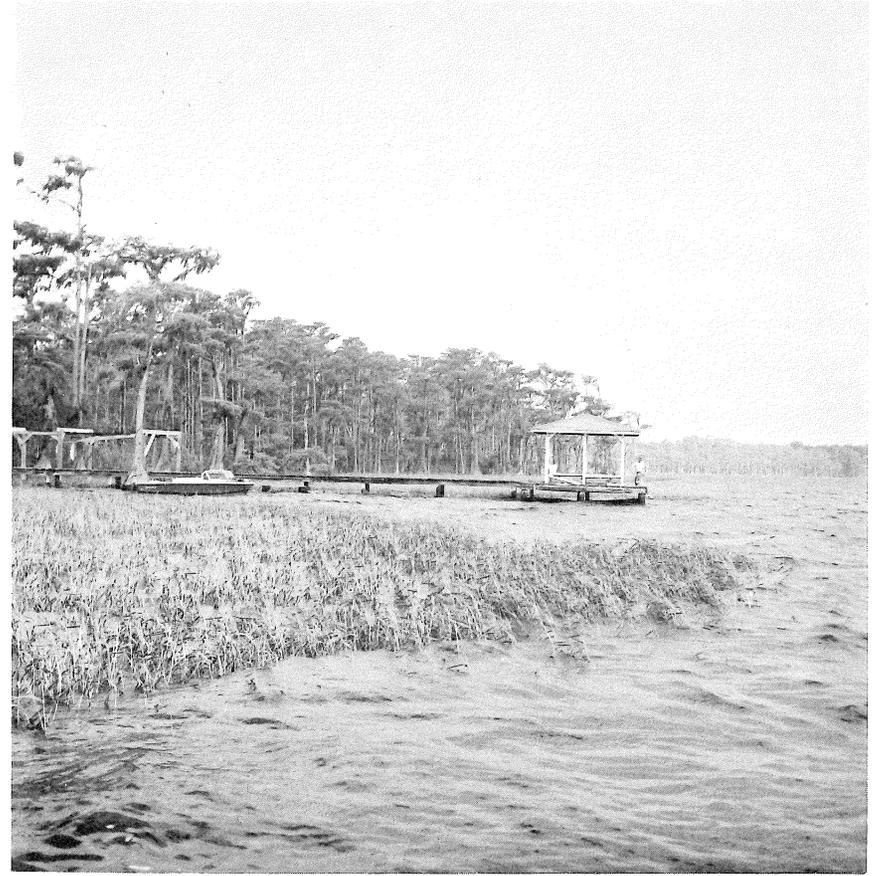
Typical border of dense maidencane in water to depths of 5-6 feet. This zone often borders Florida lake shores. With the lowering of lake levels they often persist, but are not as tall and erect.

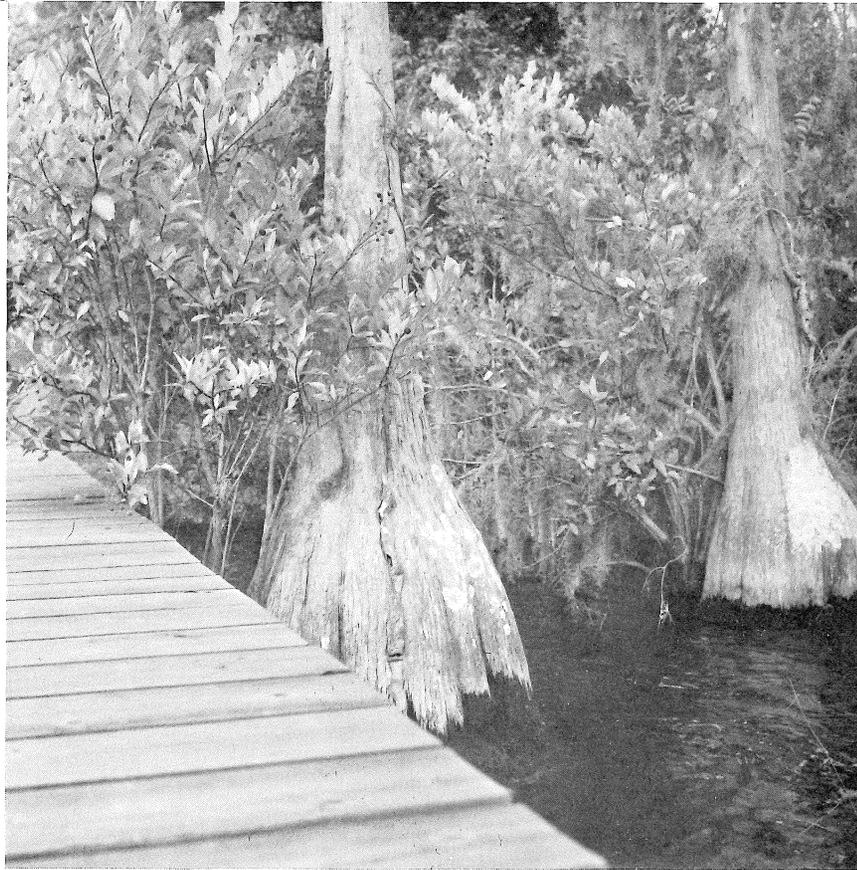
Shown above are button bushes, distinguished by fruits similar to round buttons, and two bald cypress trees. Both typically grow in water a few feet deep. Note bald cypress on right has lichen growth on its bark, the bottom of which growth indicates the highest water level.

degree of robust growth, and also by the organic character of the sediments deposited and accumulated around them. This method was used especially by Bishop (1967) (see Figure 2).

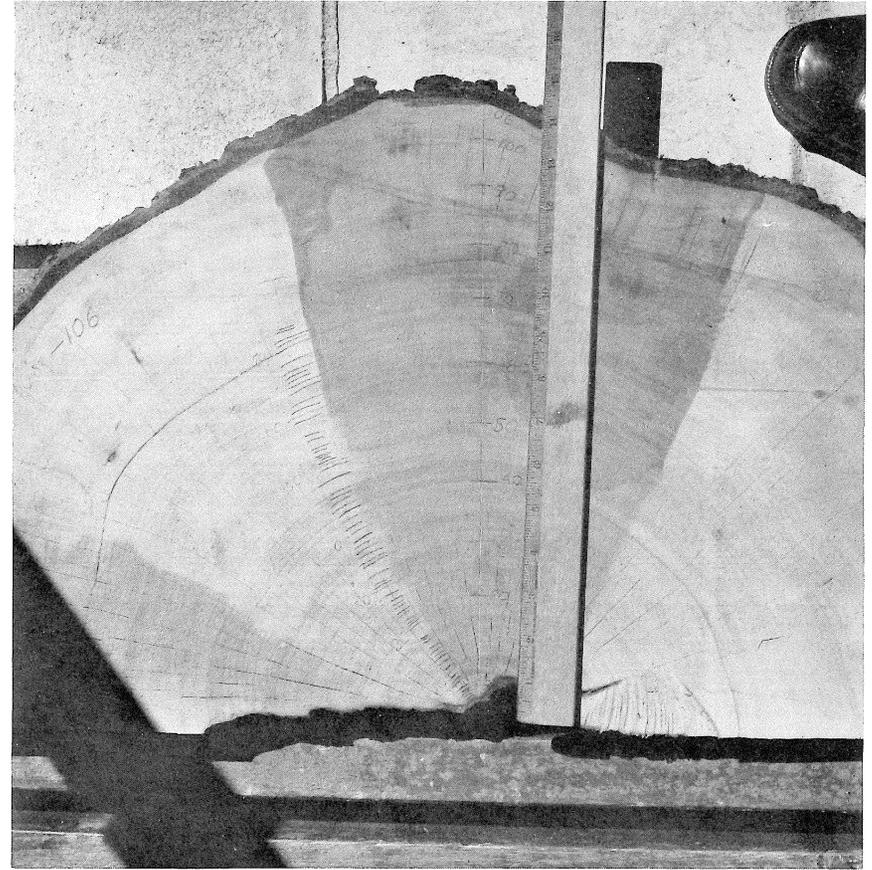
The section of a bald cypress cut near its base shows how growth rings are counted. Area near ruler was stained to increase visibility of rings.

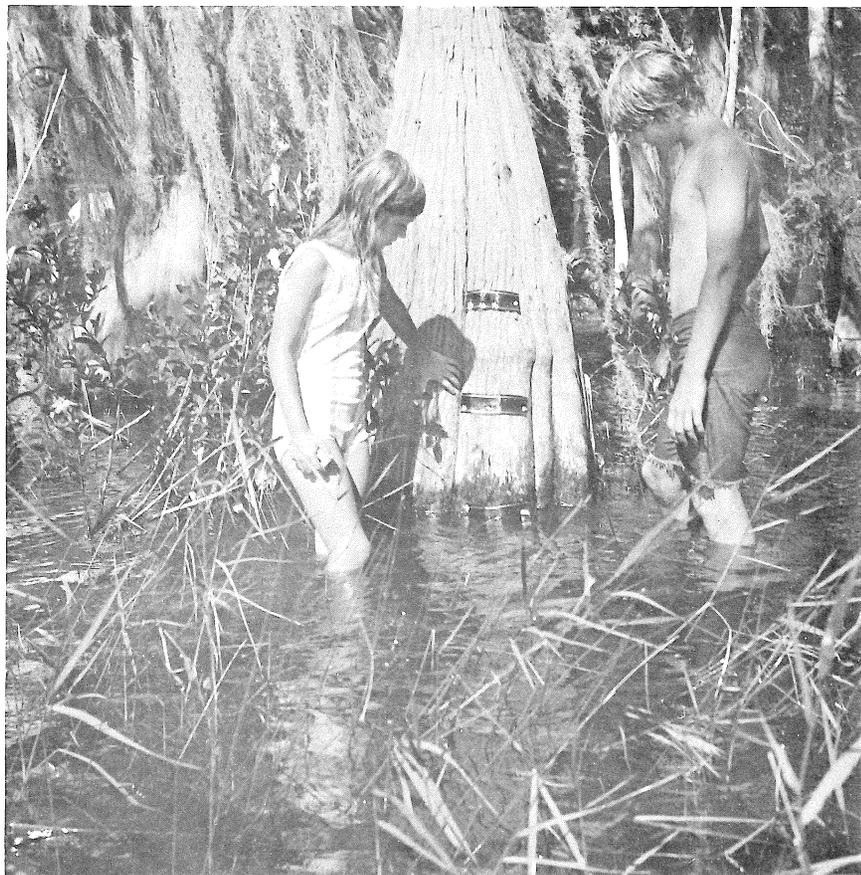
Markers on buttress of bald cypress:

Lowest -- present water level

Middle -- average water level

Upper -- highest water level

The water mark between the middle and the upper marker is probably the position of the mean high water line of this body of water.

The lower zone abuts the standing water or is, in many cases, covered by water, depending upon the season. It has the marsh and other constant hydrophytes such as cattail Typha, saw grass Mariscus, pickerelweed Pontederia, and maidencane Panicum hemitomum. Cypress, gum, willow, red maple, water ash, elderberry, and sometimes wax myrtle and buttonbush Cephalanthus, are common in this lower zone. The position of this lower zone is important in the botanical method presented here (see Figure 3).

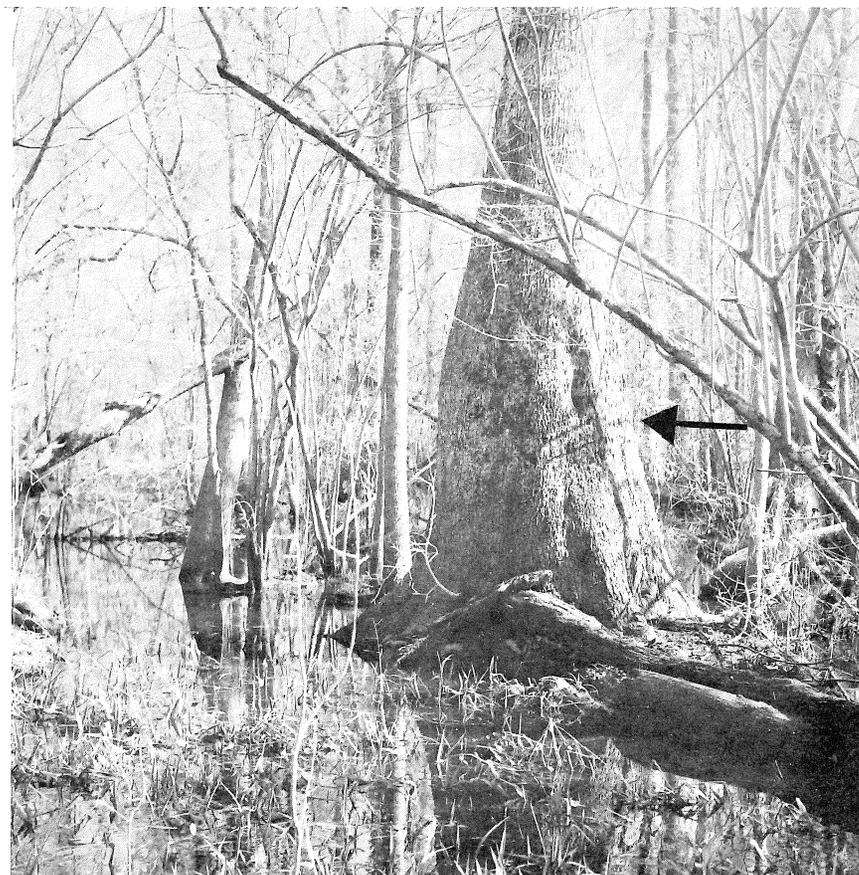
The high water line (shown by arrow) on the broad buttressed base of this tupelo gum was determined from water marks and water level records.

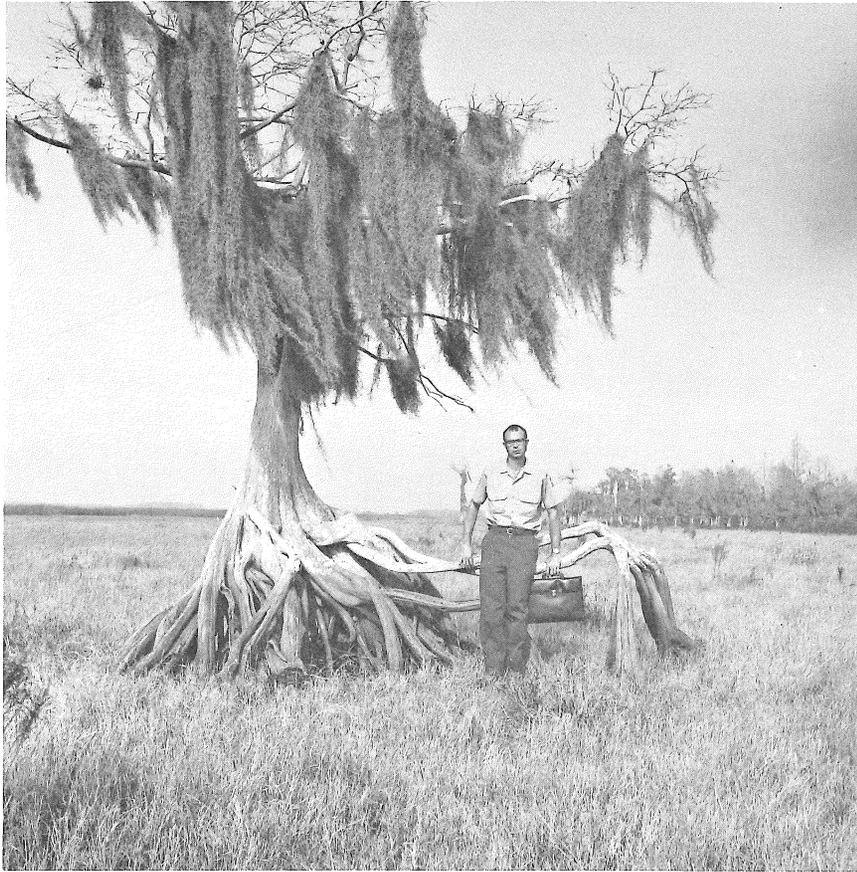
Pictured above are the roots of a bald cypress growing on the eroded berm on the eastern shore of Cypress Lake. The horizontal roots were at one time below original soil level and surface water was about up to the pockets on the man's shirt.

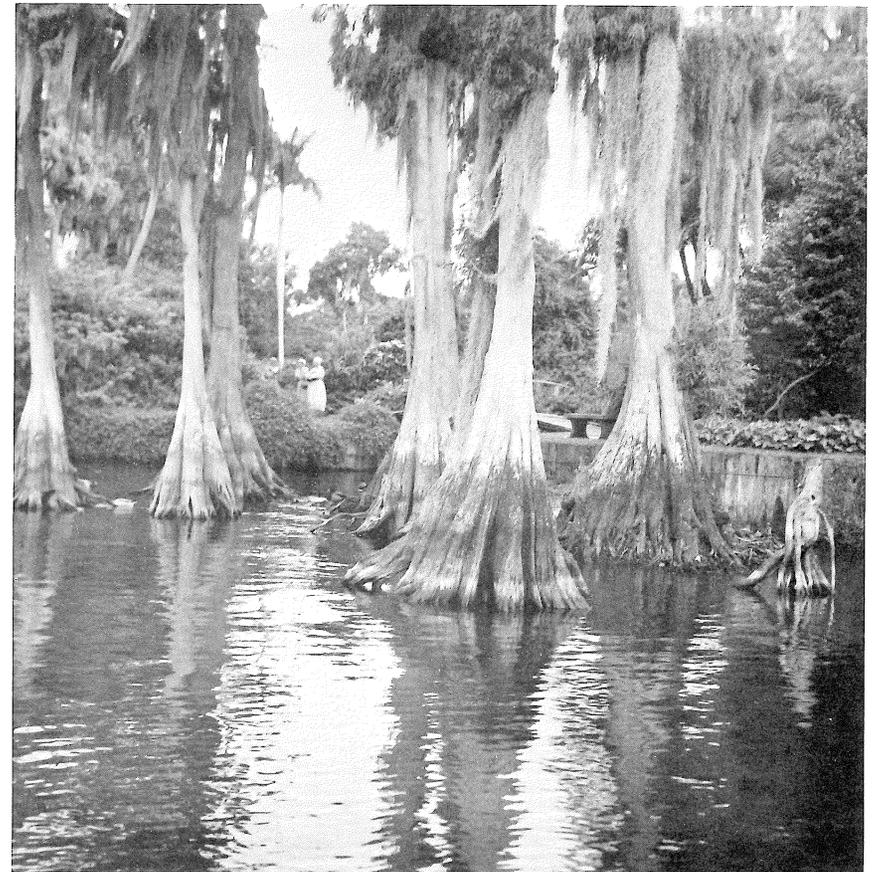
The lowering by stages of this lake exposed these bald cypress buttresses. Water marks indicate two former higher levels. Grey lichens grow down the trunks to the former highest water level.

Also many cypress have a grey moss (lichen), growing near the base of the trunk, and it was found by survey measurements that in some areas the base line of the lower part of this lichen growth was consistently at a certain level, and this level seems to be the position of ordinary high water at the time the lichen developed.

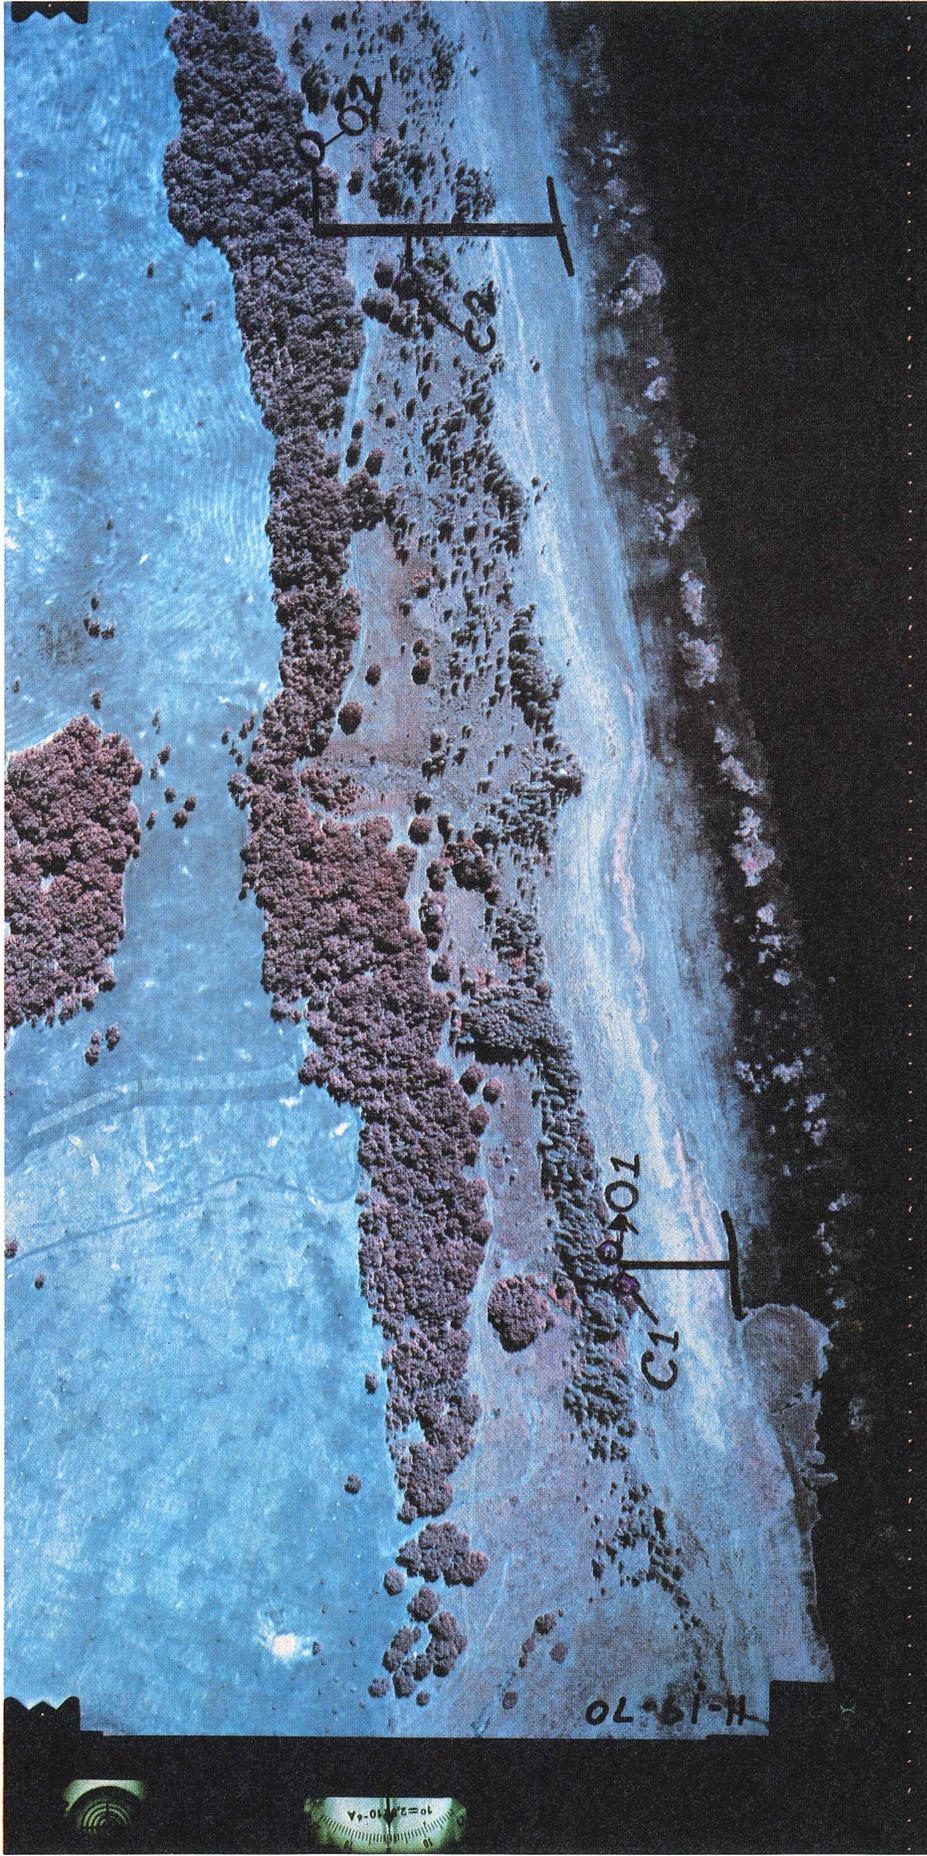
Commercial infrared aerial photograph of the east shore of Cypress Lake. Oaks and other hardwood trees have a red tinge. Cypress trees are grey. C1 and O1 indicate locations of bald cypress and live oak cut in lower berm. C2 and O2 mark the locations of bald cypress and live oak cut on higher berm. See also the profile of this shore (Figure 5).

The best method of determining approximate high-water levels is by using live oaks which are growing near cypress or gum trees. After age and elevation are determined, the former or present upper-water level can be considered to be located between the base of the live oak and the base of the cypress or gum tree. This method was used especially well on the berm ridge and slopes of both Cypress Lake and Lake Hatchineha (Plates I, II). At Cypress Lake, the position of high water was also estimated by the level of former soil. It is about one foot above the presently exposed horizontal roots. And on a berm of Lake Hatchineha the position at the base of the lichen growth was also used to estimate the former high-water line.

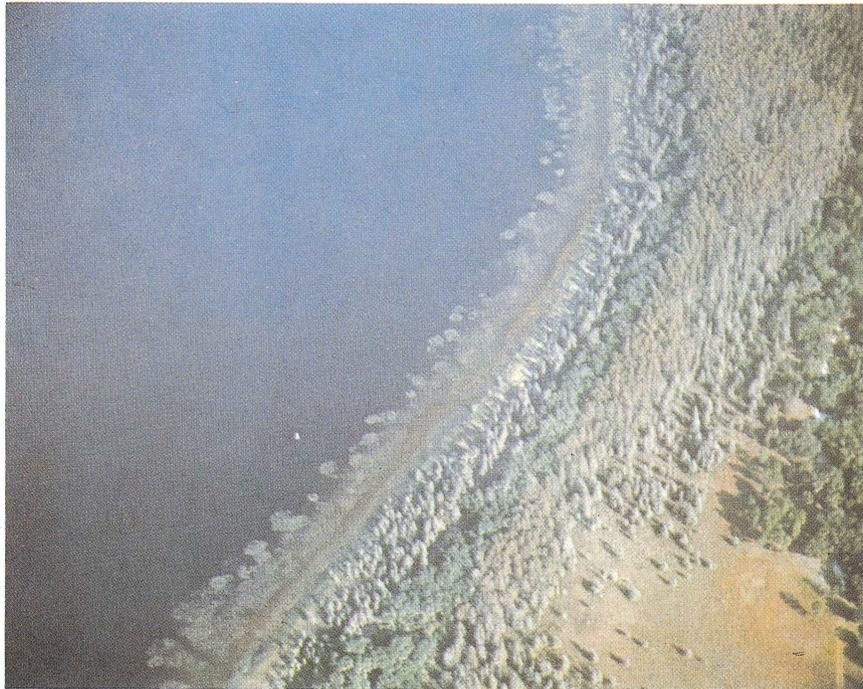
Color aerial photograph of portion of the east shore of Lake Hatchineha depicting the shoreline vegetation:

Dark green -- canopy of live oaks on top of berm ridge.

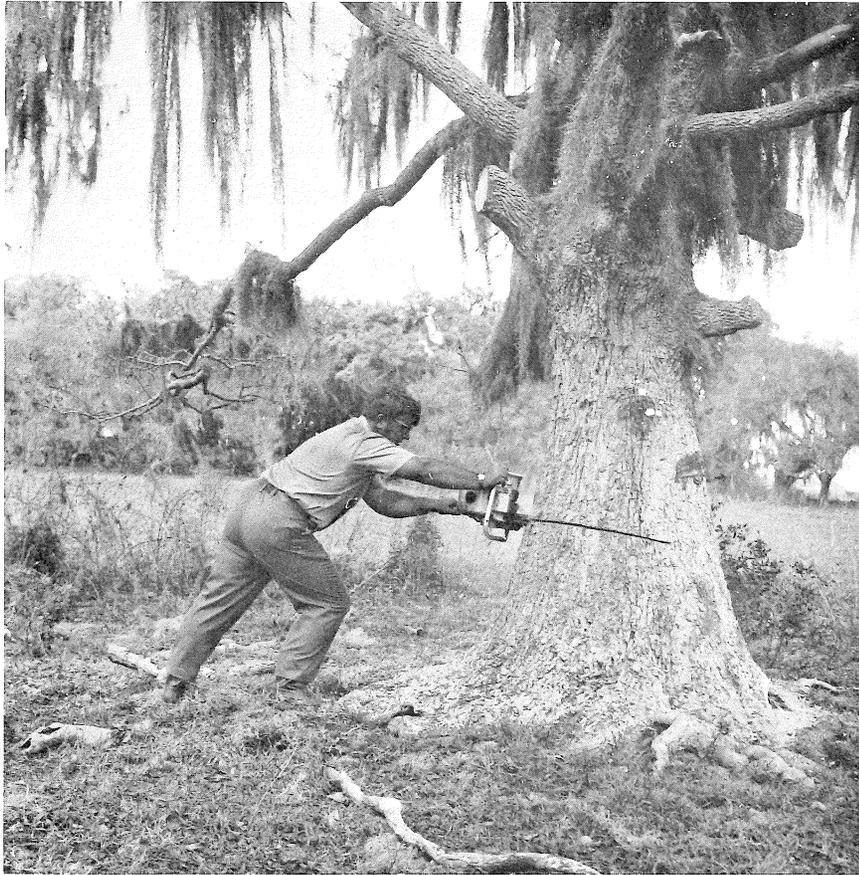
This photograph shows the cutting down of a black gum located in the swale between the two berms on the eastern shore of Cypress Lake. The buttressed base shows that surface water was present during early years of growth. The tree's calculated age of 110 years indicates a water level of 55.5 ft. MSL circa 1865.

A black gum with a distinct buttressed base was cut and sectioned. In the swale area where it grew, the elevation is 55.5 ft. MSL. Also a cypress was cut and sectioned in this swale area. It, too, was growing at an elevation of 55.5 ft. MSL. The black gum was about 110 years old and the cypress was about 115 years old. Water covered this swale area from about 1900 to as far back as 1855 or earlier (see Figure 6).

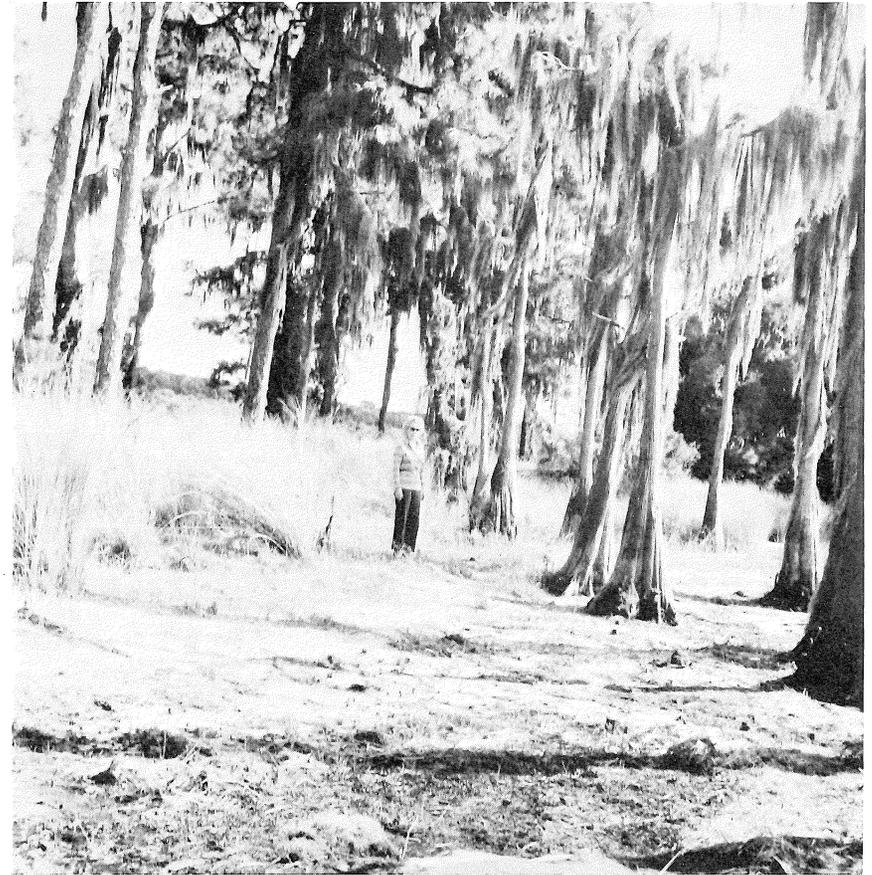
Cypress buttresses along this lake are indicative of former higher water levels. Tall switch grasses inhabit the narrow littoral zone with longleaf pines defining the highest water position.

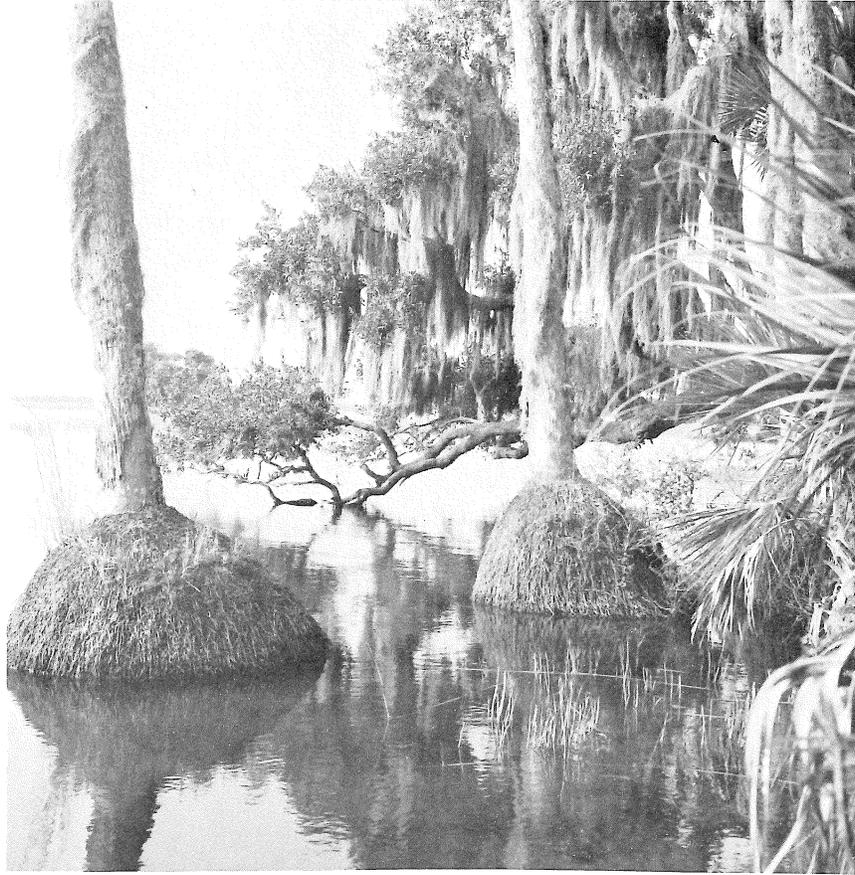
Adventitious roots of cabbage palms stand more than two feet above present water level showing the position of former higher water levels. Long limb is from a live oak growing on top of the berm on the east shore of Lake Yale.

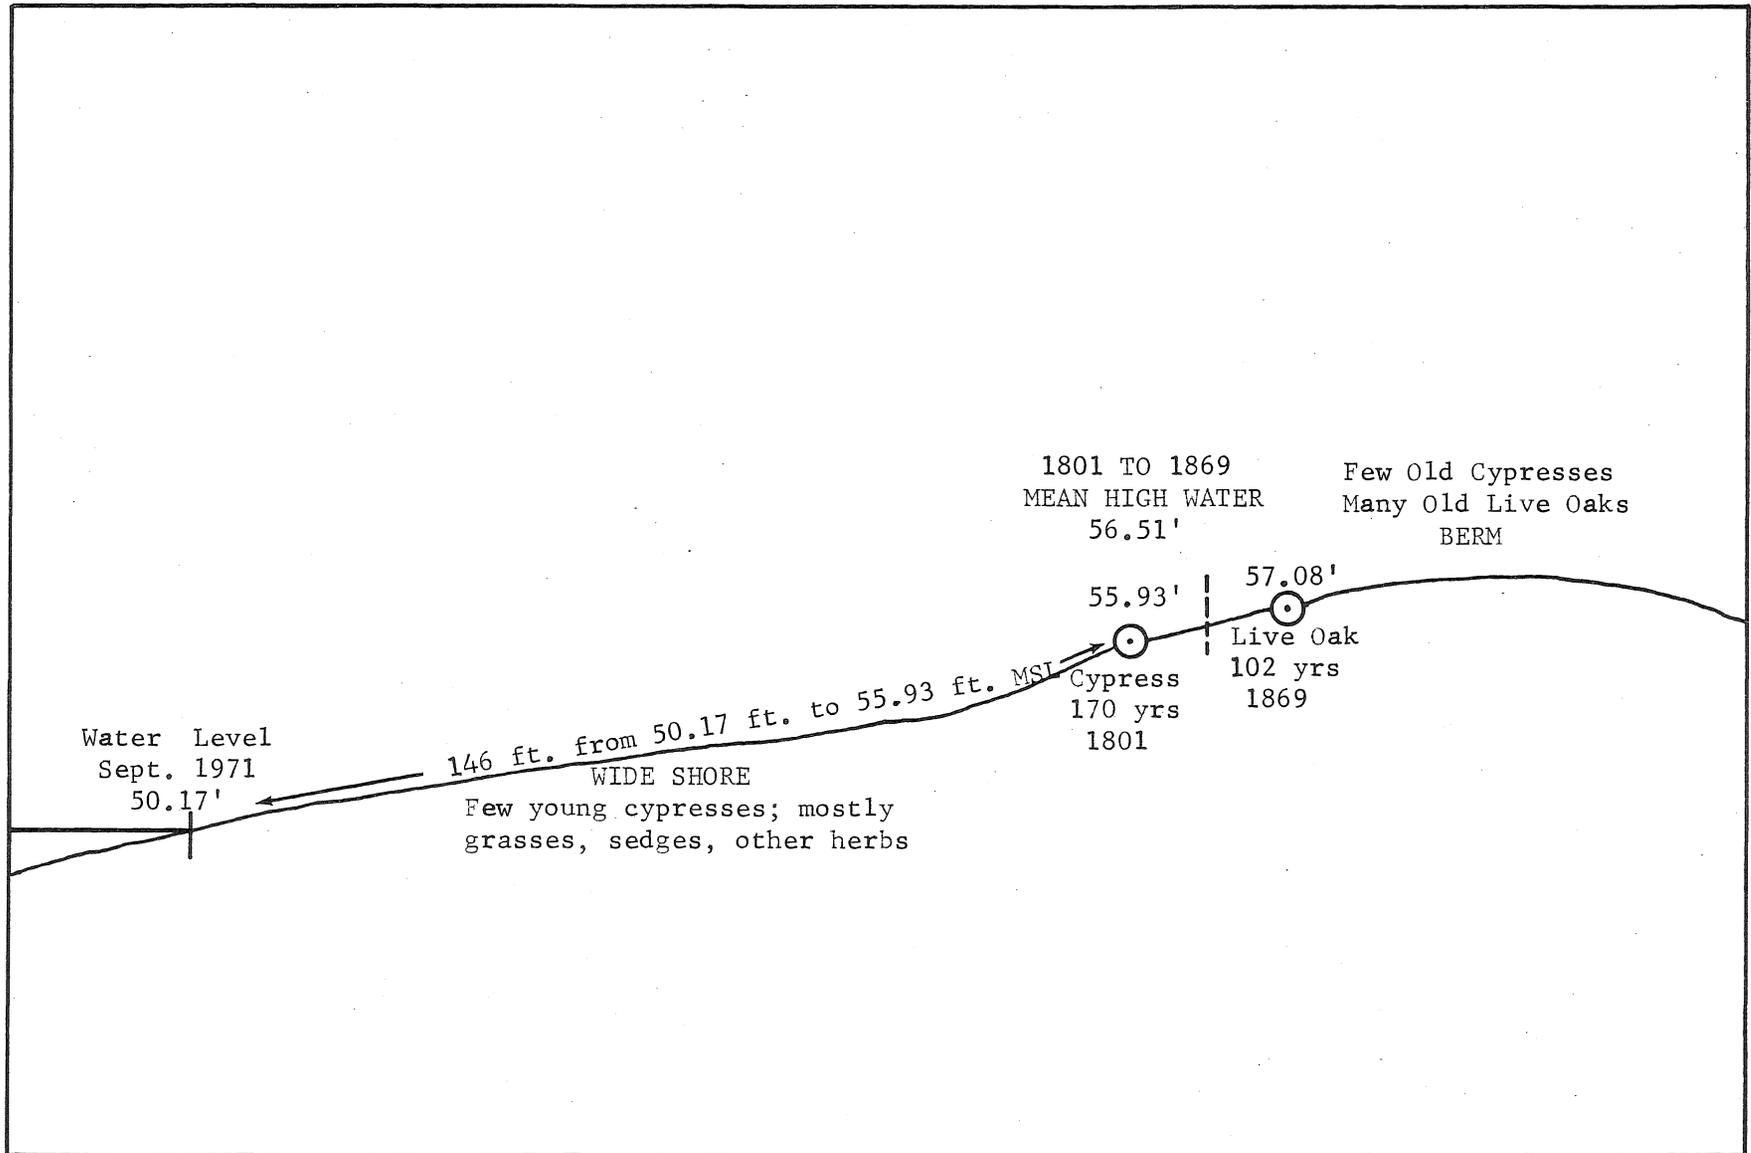
FIGURE 9. LAKE HATCHINEHA BERM
(Two Trees Cut)

Well-defined berm ridges were located on the eastern shore, and also on the southeastern shore, as shown in Figure 9. On these ridges and downslope from their tops were found cypress trees with buttresses and knees and live oak trees of large size and old age. The following is a summary of the findings.

In contrast, the two live oaks, cut and sectioned, were at elevations of 57.08 and 56.2 ft. MSL. Their ages indicated by their growth rings were 105 and 98 years, respectively. This indicates that they started growth about 1867 and 1874.

The difference in the ages of the cypresses and live oaks is about 60 to 70 years, the period between about 1805 and 1865. This indicates that the top, and near top, of the

ridge was not dry enough during those years to support the growth of live oaks, but near the top, and perhaps on it, the ridge was flooded often enough to promote the growth of cypress trees.

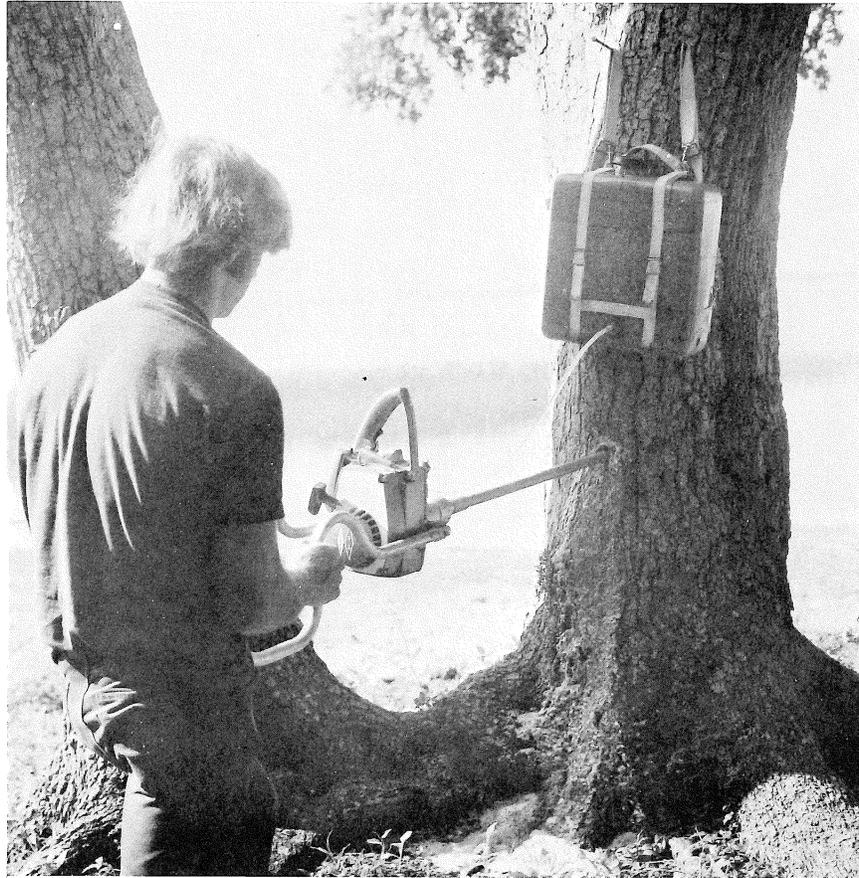
Technician using 3/4 inch power increment borer. The borer did not prove useful as seldom could the center of a tree be cored. Growth rings could not be accurately counted (especially those of live oaks) because cores are taken along the broad rays and the growth rings fail to show on ray tissue.

2. The cores through live oaks were often along the same radial direction as the radial medullary rays of the tree. These rays have no cross-growth rings that are circular. This resulted in a core that could not be read accurately. Also, the tissues involved were so difficult to stain or otherwise make more visible that any counts of growth rings were at best speculative.

3. Cores through cypress trunks near their bases (buttresses) proved readable, but a core does not show which rings are false rings and which are true annual rings. The true annual rings extend around the whole trunk and a core shows only a small three-fourths of an inch of this trunk so that distinctions of false rings compared to the true rings could not be made. And a great difficulty was experienced in getting a continuous core because the bit often overheated and burned out a section of the core.
